**DEPARTMENT OF TRANSPORTATION****DIVISION OF ENGINEERING SERVICES**

Contract #: 04-0120F4Cty: SF/ALA Rte: 80 PM: 13.2/13.9File #: 1.28**WELDING INSPECTION REPORT****Resident Engineer:** Siegenthaler, Peter**Address:** 333 Burma Road**City:** Oakland, CA 94607**Report No:** WIR-017220**Date Inspected:** 30-Sep-2010**Project Name:** SAS Superstructure**OSM Arrival Time:** 1000**Prime Contractor:** American Bridge/Fluor Enterprises, a JV**OSM Departure Time:** 1830**Contractor:** American Bridge/Fluor Enterprises, a JV**Location:** Job Site

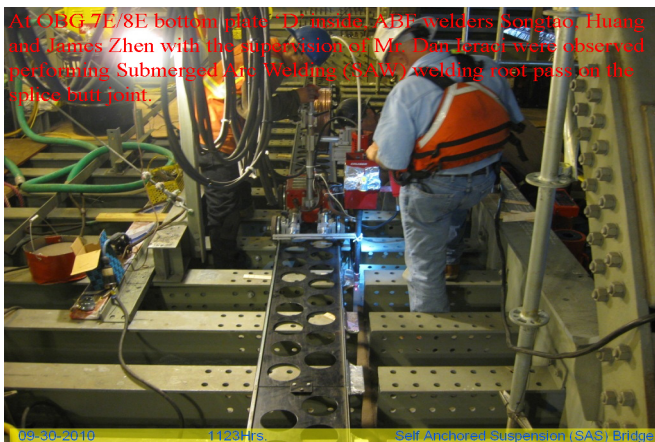
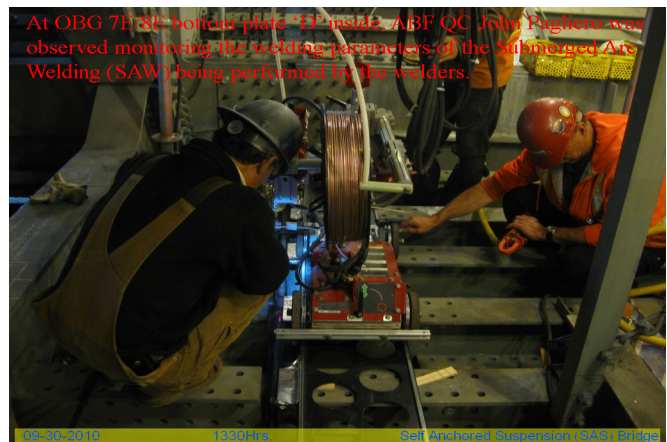
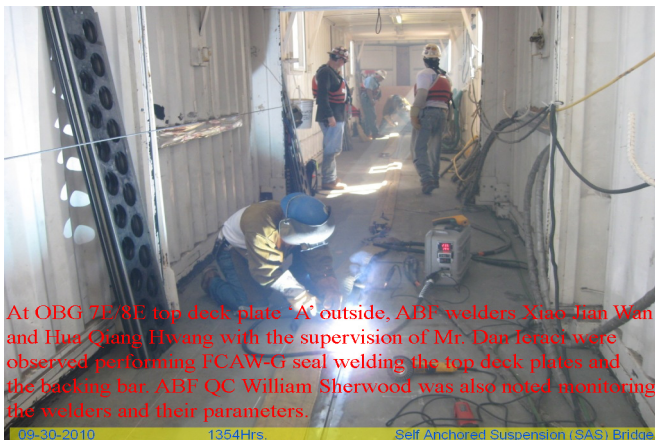
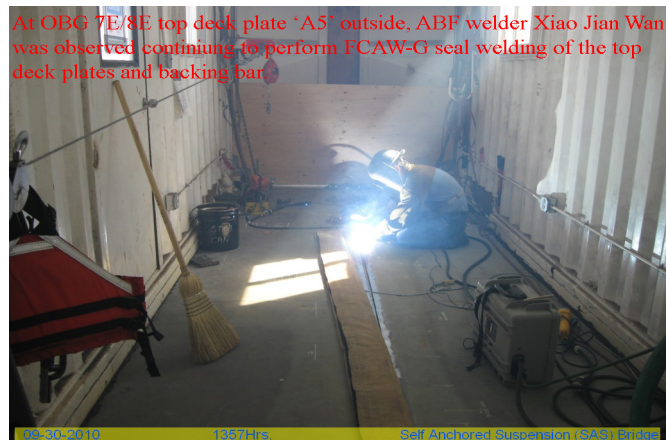
At OBG 7E/8E top deck plate A1 to A5 outside, QA randomly observed ABF/JV qualified welders Xiao Jian Wan and Hua Qiang Huang seal welding top deck plates 'A1 to A5' to the backing bar. The welders were utilizing a dual shield Flux Cored Arc Welding (FCAW-G) with E71T-1M, 1/16" diameter wire electrode and implementing Caltrans approved Welding Procedure Specification (WPS) ABF-WPS-D15-3040A-1. The joint had a single V-groove butt joint design with the bottom plate being seal welded with backing bar. The plate with the backing bar was preheated to greater than 150 degrees Fahrenheit using Miller Proheat 35 Induction Heating System heater blankets located at the top of the plate prior welding and moving to the side of the plate during welding. During the shift, ABF QC William Sherwood was noted monitoring both welders with welder Xiao Jian Wan and Hua Qiang Huang having noted welding parameters of 245 amperes/23.5 volts and 250 amperes/23.2 volts respectively which deemed in compliance to the contract requirements. The welders have not completed the seal welding of the joint during the shift and should continue tomorrow.

At OBG 7E/8E bottom plate 'D' inside, QA randomly observed ABF certified welder James Zhen ID #6001 and Songtao, Huang ID #3794 perform 1G (flat position) Submerged Arc Welding (SAW) welding root pass then fill pass on the CJP splice butt joint. The welders were utilizing F7A6-EM12K-H8, 3.2mm electrode with corresponding Esab OK Flux 10.62 flux and implementing Caltrans approved Welding Procedure Specification (WPS) ABF-WPS-D15-4042B-1. The joint being welded had a single V-groove butt joint with backing bar. The

plates were preheated to more than 150 degree Fahrenheit using Miller Proheat 35 Induction Heating System heater blankets located at the opposite side of the plate prior/during welding. Welding parameters were monitored by ABF/QC William Sherwood. QA noted the welding parameters, the workmanship and appearance of the completed fill deemed satisfactory. At the end of the shift, SAW fill pass welding was still continuing and should remain tomorrow.

At OBG 6W/7W edge plate 'B' inside, QA randomly observed ABF/JV qualified welder Jin Pei Wang ID #7299 back welding cover pass on the Complete Joint Penetration (CJP) splice butt joint. The welder was observed manually welding in the 3G (vertical) position utilizing a Shielded Metal Arc Welding (SMAW) with 1/8" diameter E7018H4R electrode and implementing Caltrans approved Welding Procedure Specification (WPS) ABF-WPS-D15-3110-3. The joint being welded has a single V-groove butt joint with copper backing bar that has been removed and back gouged. The groove of the ground and gouged area of the copper backing bar was also tested and passed using Magnetic Particle Testing (MT). During welding, ABF Quality Control (QC) John Pagliero was noted monitoring the welding parameters of the welder. During the shift, cover pass SMAW welding on the edge plate was completed and has moved to other edge plate 'F' of the same OBG. The welder was observed welding in the same position using the same process as mentioned above. At the end of the shift, cover pass welding on this joint was still continuing and should continue tomorrow.
